Cold Spring Fire

A Case Study of 141 Sherwood Road, Nederland, Colorado
Boulder County Wildfire Partners Program

November 2016

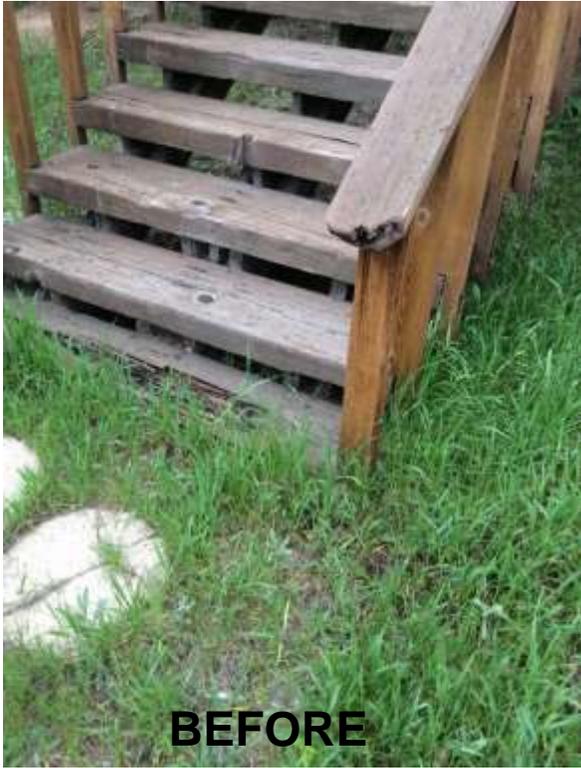
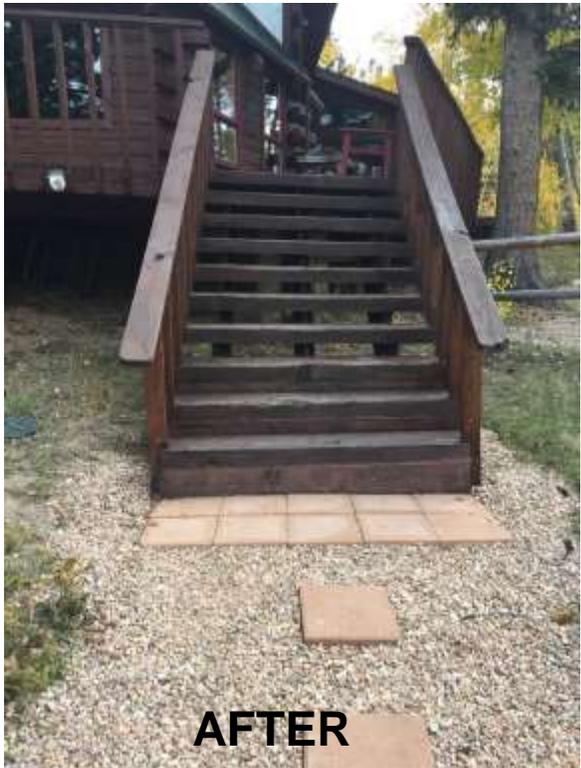
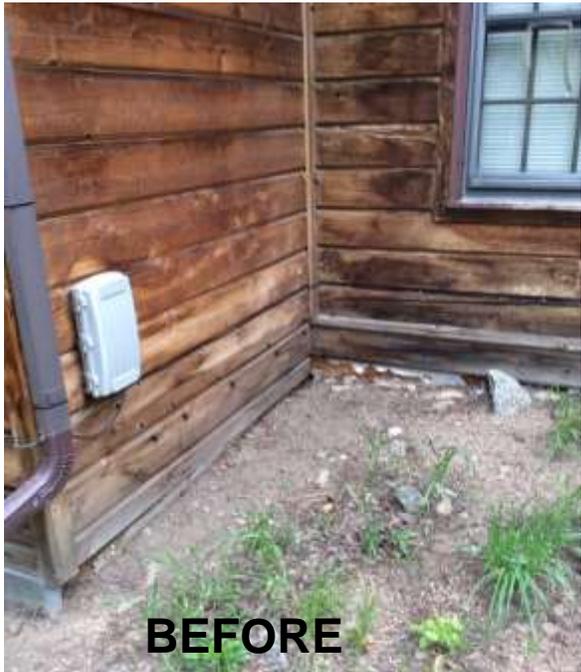
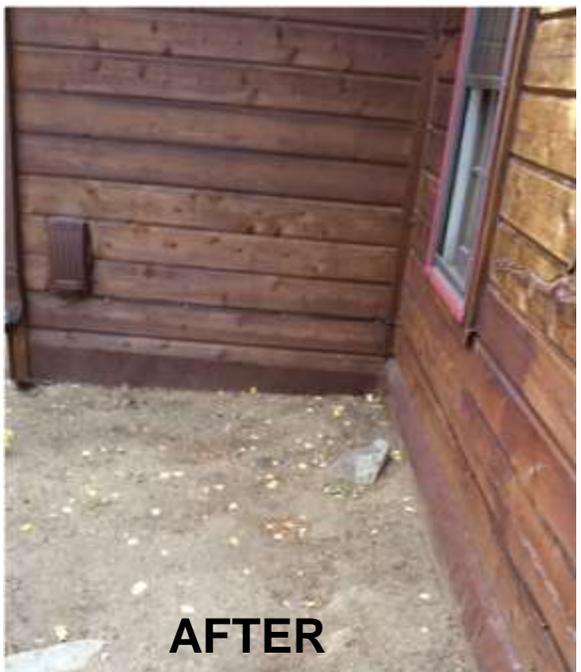
Mr. Lanham received his assessment on June 8, 2014 and earned his certificate the following summer on October 17, 2015. His assessment focused primarily on two major mitigation areas: the condition of his log home and deck, and vegetation within Zone 1A. Specifically, the property had several vulnerabilities to ember intrusion: lumber stacked beneath the deck, collection of needles under the deck, wooden siding junction with the wooden deck, large cracks in several aged deck boards, fine fuels at the base of wooden deck steps, and a wooden fence connected to the deck.

Figure 1. Before/After Mitigation Photos at 141 Sherwood Road (primary structure). Top left: condition of stairs and grass before mitigation (2014); top right: installation of a non-combustible border, repaired and sealed deck boards to eliminate any significant gaps or cracks (2016); bottom left: base of walls without flashing and vegetation (2014); bottom right: non-combustible metal flashing extending several inches from wall base, removal of all vegetation near structure (2016).

Mitigation actions focused on: sealing deck board cracks, replacing base of wooden stairs with non-combustible materials, consistently installing flashing at the base of all siding walls, removing scrap lumber and needles from below the deck, removing and/or mowing grassy areas near the deck and porch stairs, ensuring a 5 ft. non-combustible zone extended around the house (including the deck), and covering areas with 1/8" metal meshing to protect against accumulating leaf and needle debris (see Figure 1 below for before/after examples). Mr. Lanham estimated that his home retrofits cost less than \$400 in total.

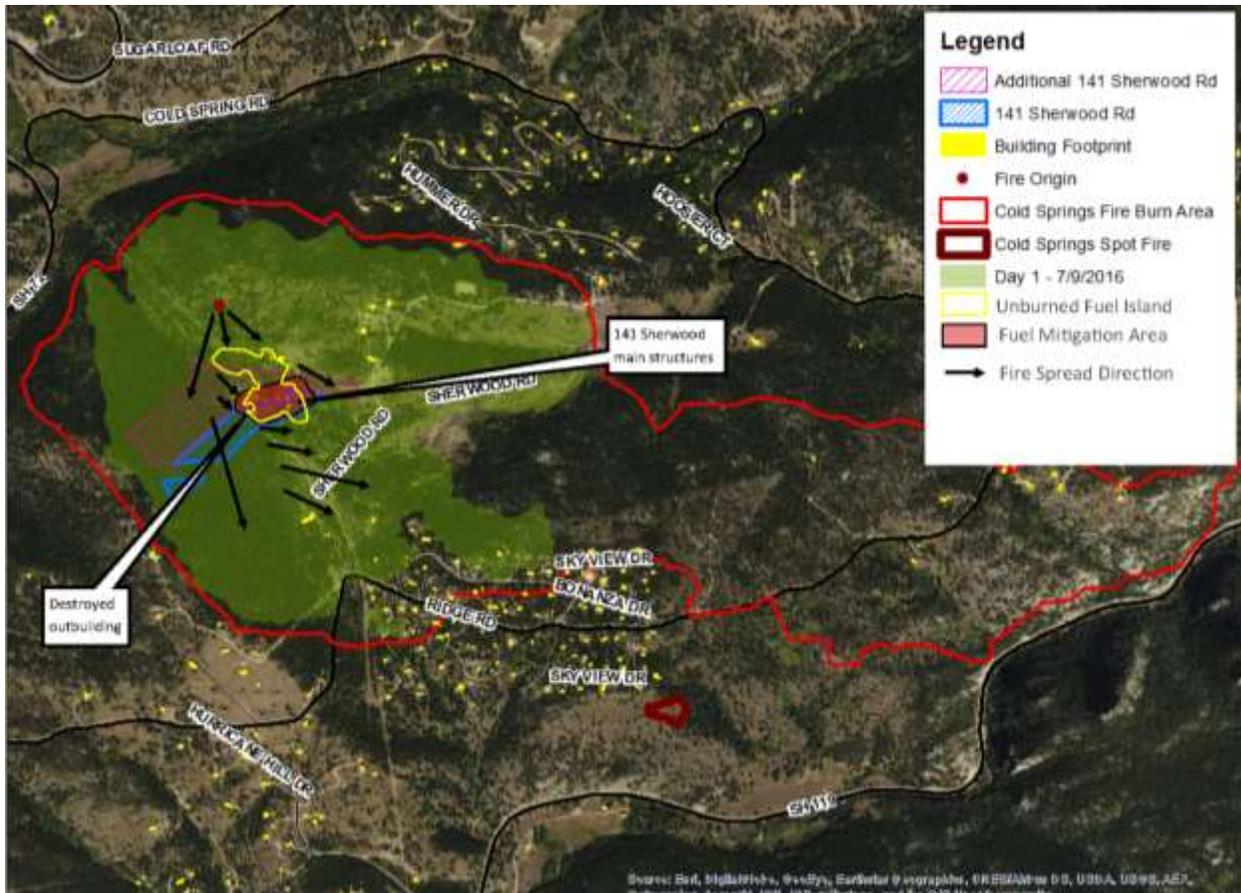
The mapped fire perimeter supported by witness accounts, ortho photo interpretation, and on site tree scorch and burn pattern assessment indicate the fire approached the property from the downhill/ down drainage and northwest direction. The above evidence also suggests that the fire split downhill of the property to flank the southwest and northeast slopes of the drainage, and subsequently the southwest and northeast sides of the property. The southwest finger of the fire appeared to burn predominantly cross slope on Hurricane Hill and in a southeasterly direction, exhibiting crown fire behavior for the majority of the distance. The primary burning activity that challenged the 141 Sherwood Drive property occurred in the first burning period on July 9, 2016. (Figure 2).

Witness accounts describe the south west flank of the fire turning downhill and spreading in an east northeast direction towards the property. The mapped burn perimeter, ortho photo interpretation, along with onsite tree scorch patterns and other onsite burn indicators support this account.

Ortho photo interpretation and onsite indicators suggest the northeast flank of the fire initially burned uphill and then transitions to a southeast spread direction, exhibiting intermittent crown fire behavior, destroying a neighboring structure and flanking the property on the northeast side.

Figure 2. Cold Springs Fire ortho photo with estimated burn perimeter (red polygon) and suggested fire spread direction in relation to the 141 Sherwood Rd main structures and surrounding unburned fuel island (yellow polygon). Estimation based on witness accounts, site visit observations and ortho photo interpretation and burn perimeter map supplied by Boulder County.

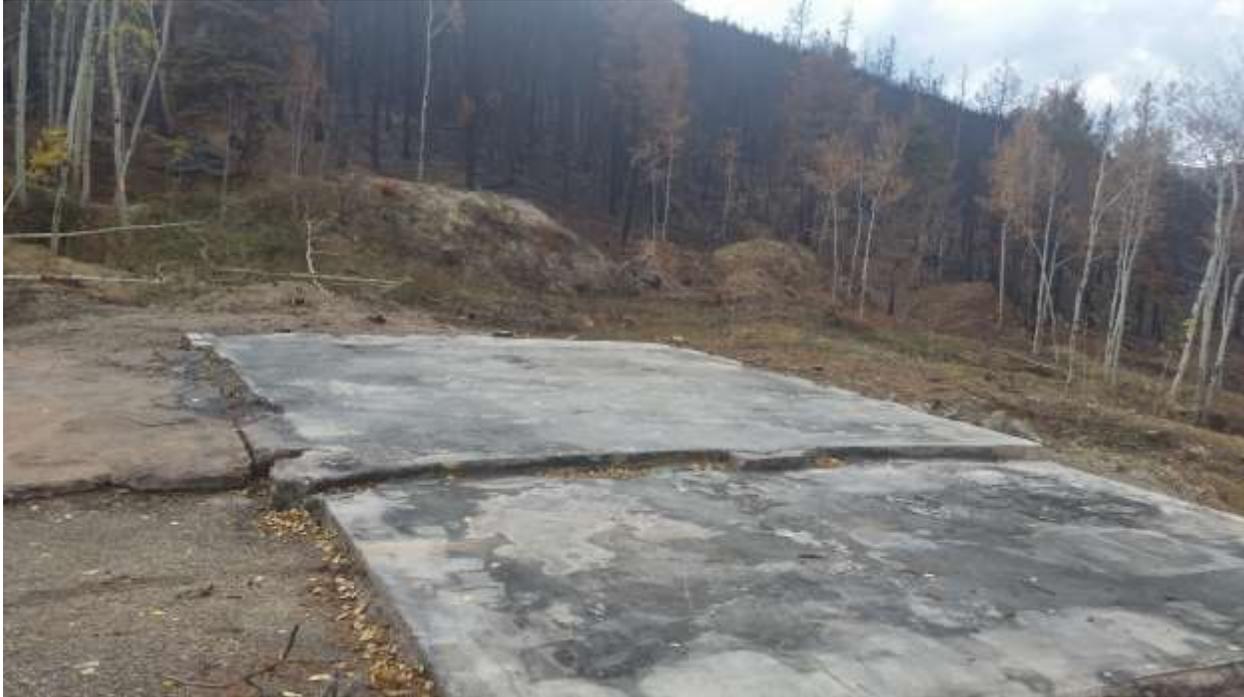
Crown fire activity through the southwestern portion of the property consumed the majority of the trees present on the northeast facing slope of Hurricane Hill. One outbuilding southeast to the main structures was destroyed in the fire. Onsite indicators suggest airborne embers to be the likely ignition source (Figure 3).

Figure 3. Foundation of an out building, located approximately 315 feet to the southwest of the main structures and 70 feet to the northeast of crown scorched trees, destroyed as a result of suspected ember ignition.

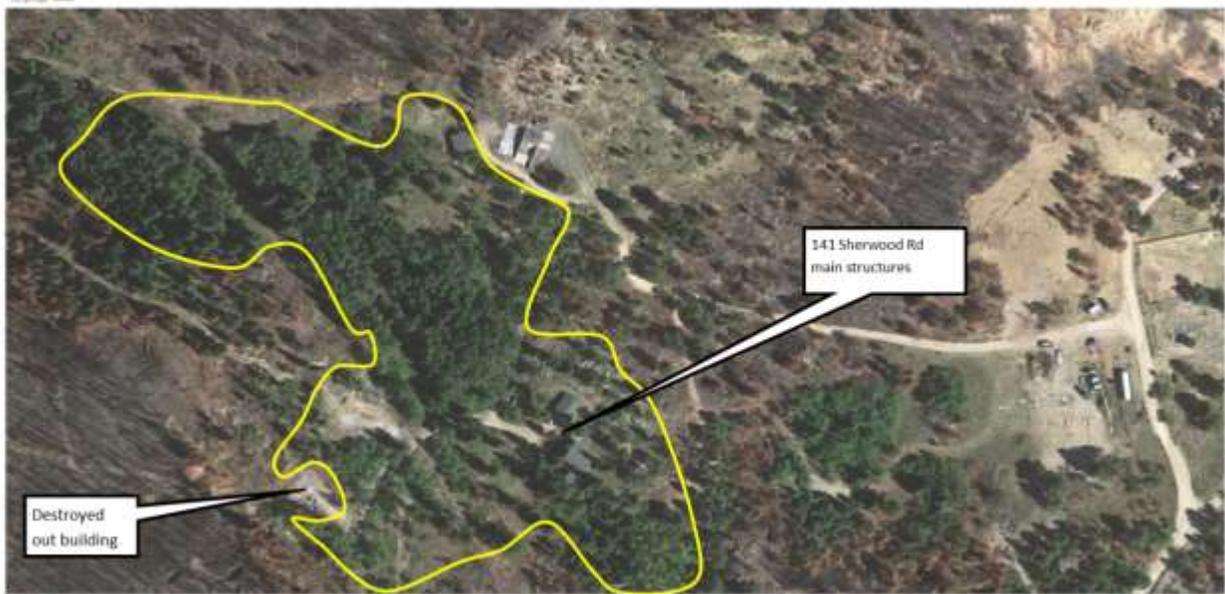
Excluding the above ember impingement, the closest surface fire impingement into the property was a backing fire which burned within 55 feet to the northwest of the detached garage in light litter and cured/matted grass (Figures 4 and 8). This fire also self-extinguished without firefighter intervention.

Figure 4. 141 Sherwood main structures (house and detached garage) and surrounding unburned vegetation perimeter. Burned area includes out building destroyed as a suspected result of ember ignition. The structure directly to the north of the 141 Sherwood property was also lost in the fire.

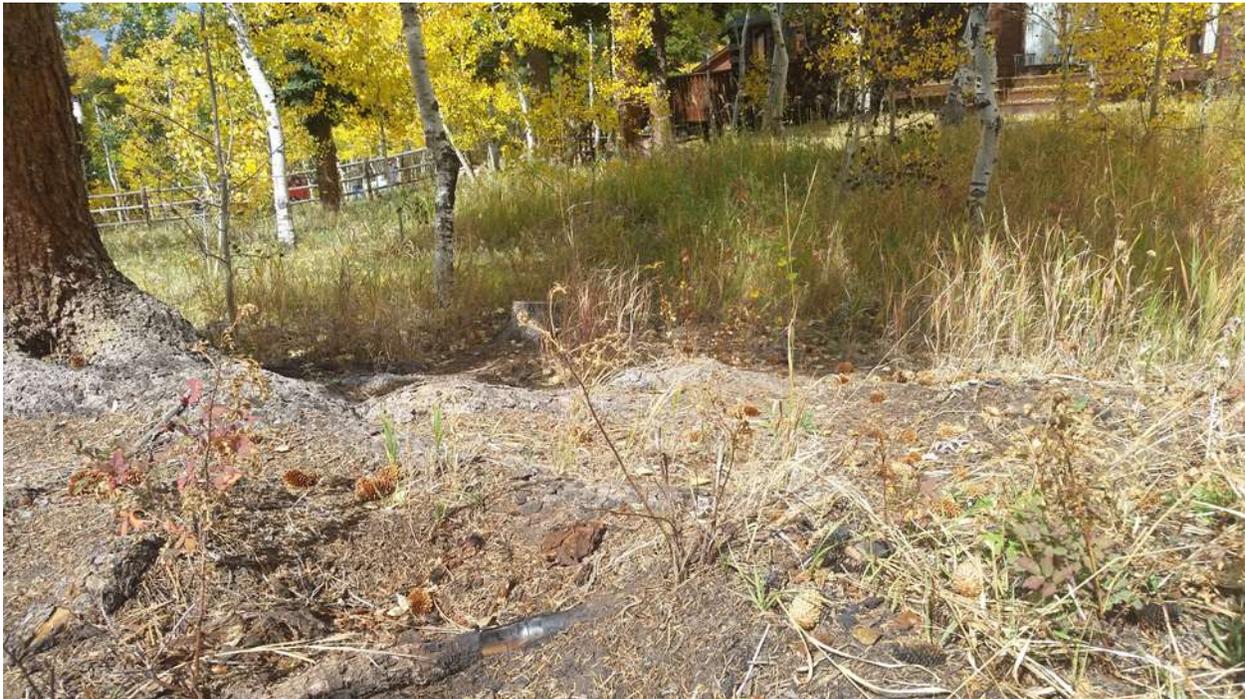
Figure 5. The closest ember ignition evidence to the main structure was at 36 feet to the southwest.

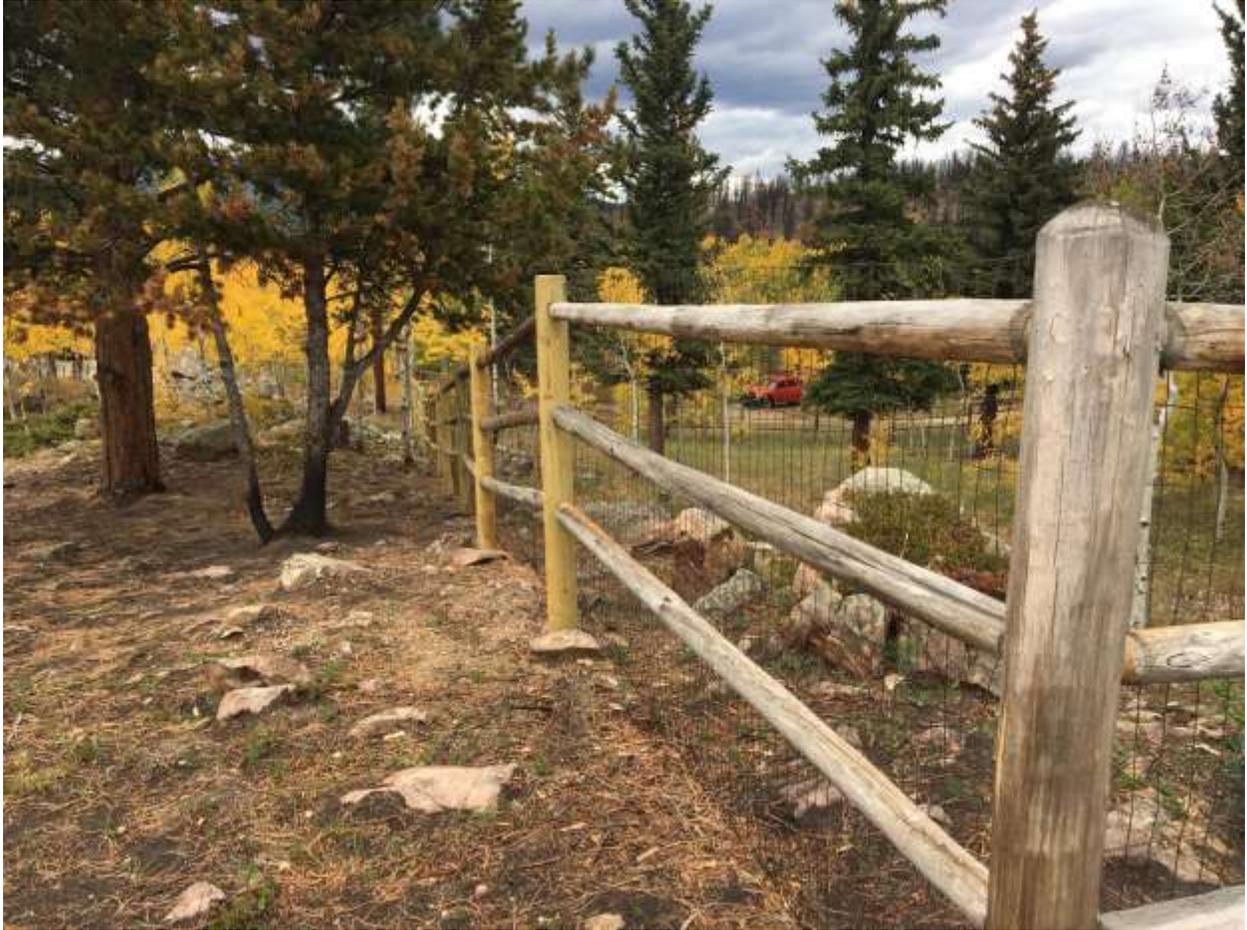
Figure 6. Evidence of Southwest ember ignition (80 feet from the main structure) and resulting uphill fire spread (away from the structure to the southeast) in tall standing grass and juniper. Fence in the photo is the replacement fence.

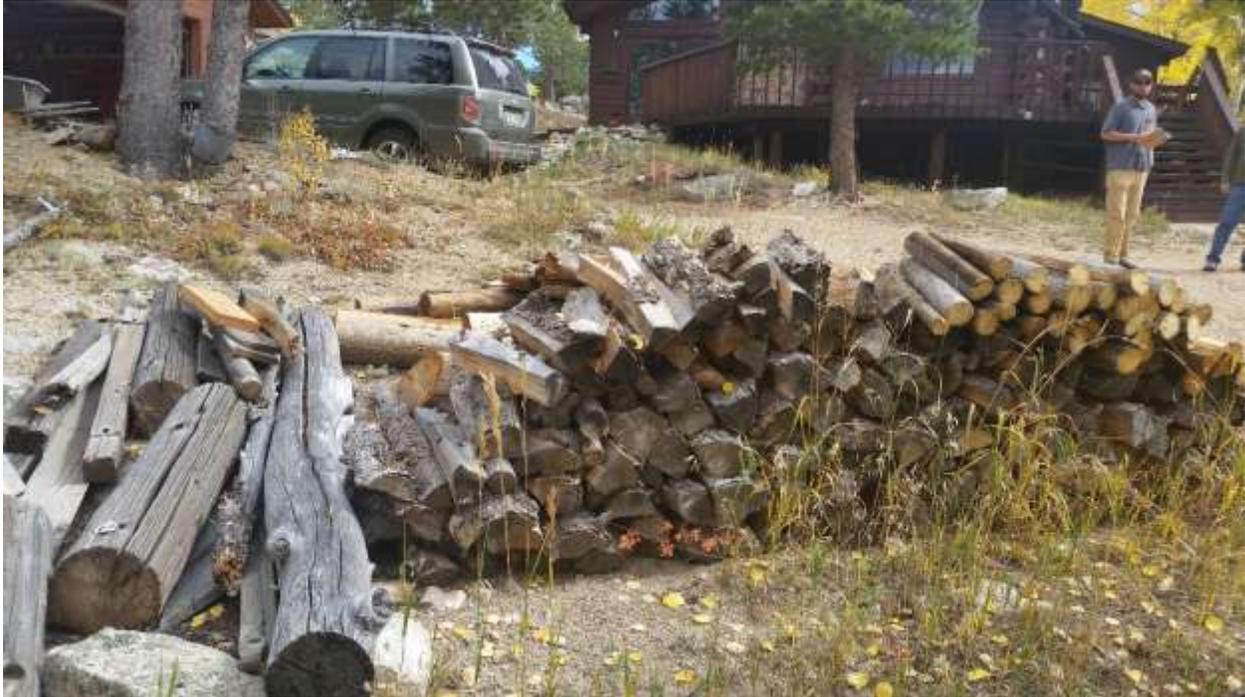
All burn indicators suggest that the central portion of the property was initially largely exposed to a flanking and backing fire only and not the head fire (Figure 2). Secondly, the fire turned to an easterly/south easterly direction, further exposing the property to a flanking and backing fire. Witness accounts describe airborne ember activity in the immediate vicinity of the main structures during this fire spread event; however, the closest evidence of successful ember ignition is at 36 feet southwest of the main structure in light matted grass and surface litter (needles and small twigs), where minimal spread occurred (maximum 1 foot in diameter) and self-extinguishment without firefighter intervention occurred (Figures 4 and 5). Ember ignition also occurred at a distance of 80 feet southwest of the structure, where remaining vegetation and juniper shrub were ignited and wooden fence posts were consumed as the resulting surface spread uphill (southeast) and away from the main structure (Figures 4 and 6). The wood post and rail fence did not sustain damage beyond the sections immediately adjacent to heavier vegetation (tall grass and juniper shrub) and self-extinguished without firefighter intervention did occur. An existing firewood pile (considered highly combustible) located at 30 feet to the northwest of the main home and detached garage, and approximately 200 feet from the closest crown fire activity did not show evidence of ember ignition (Figure 7).

Figure 7. Firewood pile located at 30 feet to the northwest of the main structure and detached garage and approximately 200 feet from crown fire activity did not show evidence of ember ignition

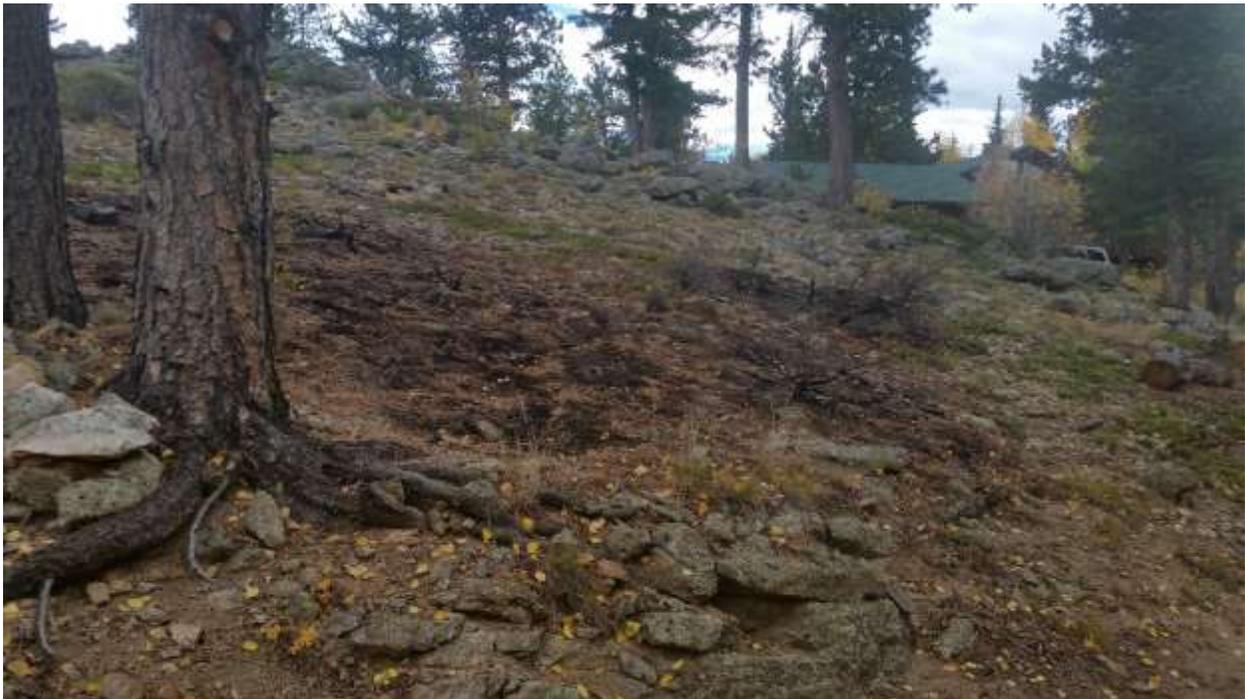
Figure 8. Evidence of the closest backing fire impingement from the northeast at 55 feet
