Cold Spring Fire

A Case Study of 141 Sherwood Road, Nederland, Colorado
Boulder County Wildfire Partners Program

November 2016

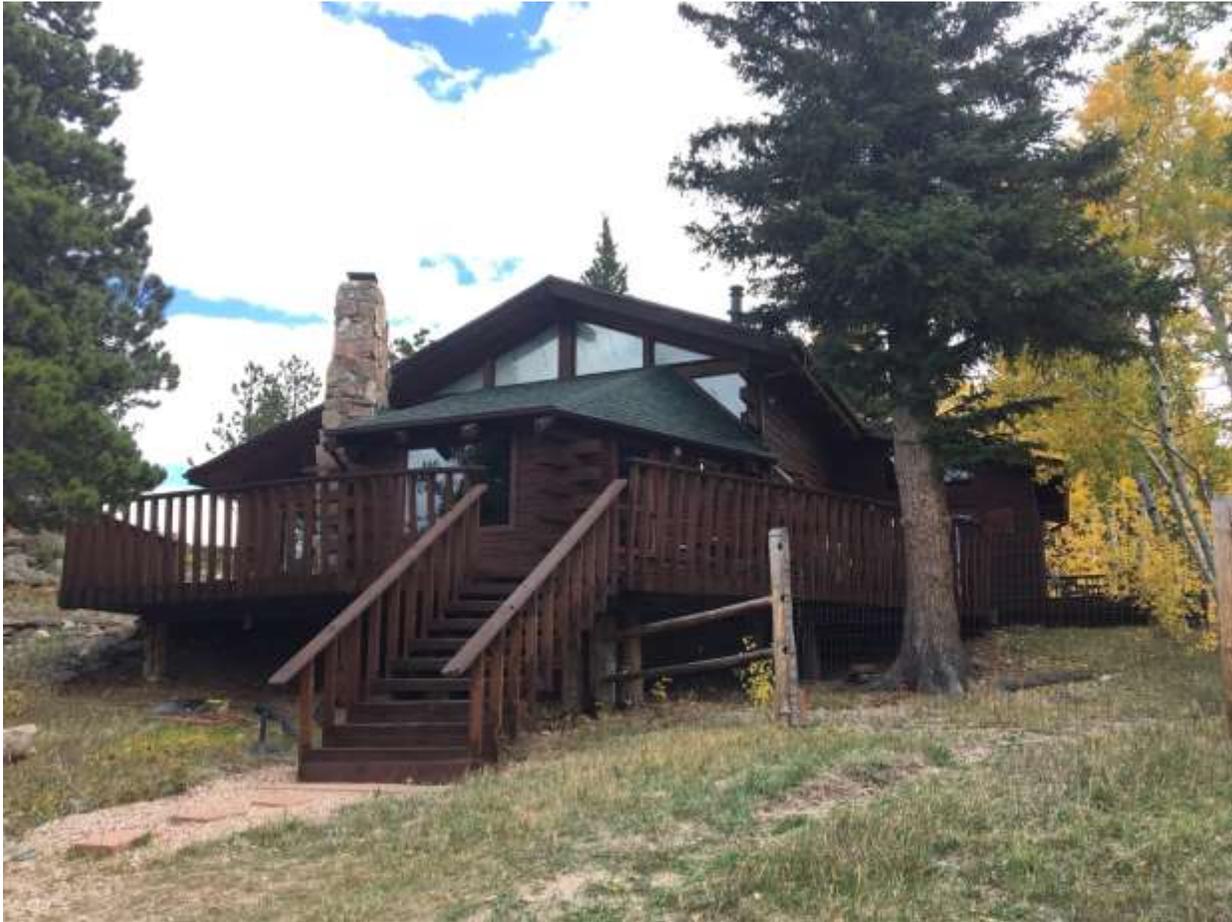
Mr. Lanham received his assessment on June 8, 2014 and earned his certificate the following summer on October 17, 2015. His assessment focused primarily on two major mitigation areas: the condition of his log home and deck, and vegetation within Zone 1A. Specifically, the property had several vulnerabilities to ember intrusion: lumber stacked beneath the deck, collection of needles under the deck, wooden siding junction with the wooden deck, large cracks in several aged deck boards, fine fuels at the base of wooden deck steps, and a wooden fence connected to the deck.

Figure 1. Before/After Mitigation Photos at 141 Sherwood Road (primary structure). Top left: condition of stairs and grass before mitigation (2014); top right: installation of a non-combustible border, repaired and sealed deck boards to eliminate any significant gaps or cracks (2016); bottom left: base of walls without flashing and vegetation (2014); bottom right: non-combustible metal flashing extending several inches from wall base, removal of all vegetation near structure (2016).

Mitigation actions focused on: sealing deck board cracks, replacing base of wooden stairs with non-combustible materials, consistently installing flashing at the base of all siding walls, removing scrap lumber and needles from below the deck, removing and/or mowing grassy areas near the deck and porch stairs, ensuring a 5 ft. non-combustible zone extended around the house (including the deck), and covering areas with 1/8" metal meshing to protect against accumulating leaf and needle debris (see Figure 1 below for before/after examples). Mr. Lanham estimated that his home retrofits cost less than \$400 in total.
